**UNITED STATES ENVIRONMENTAL PROTECTION AGENCY**

Re: Notice of Violation  
RCRA Compliance Evaluation Inspection – Mid-City Plating Company  
EPA I.D. No.: IND 006 049 456

# Photographs for Mid City Plating Company CEI 6/22/2010

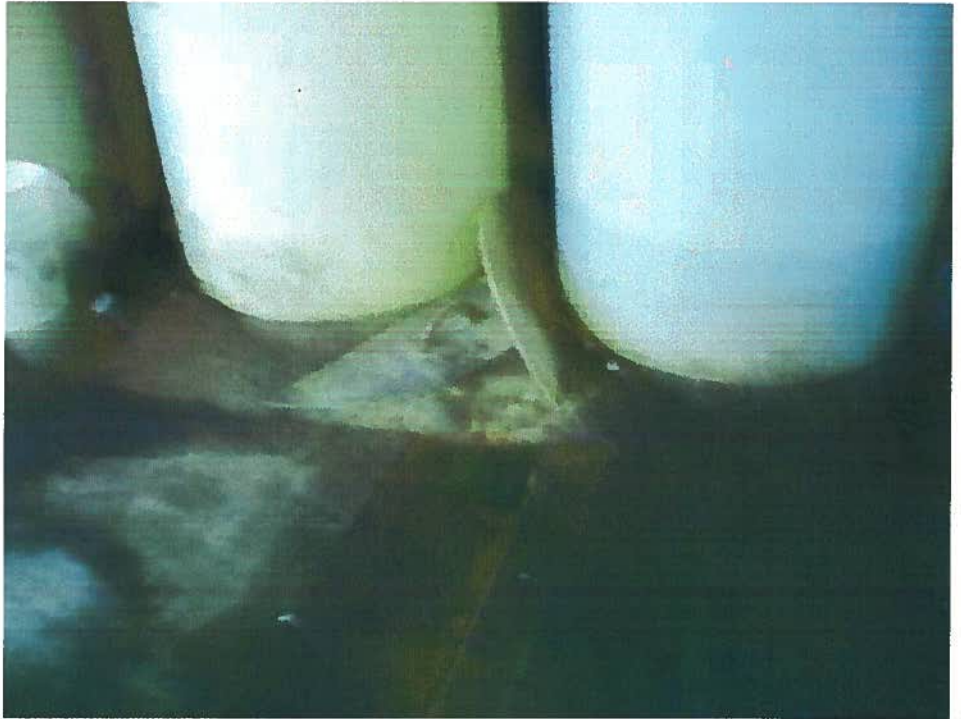
WWT unit. Liquid was located on the floor.  
300 gallon sump pit was located underneath  
the unit.

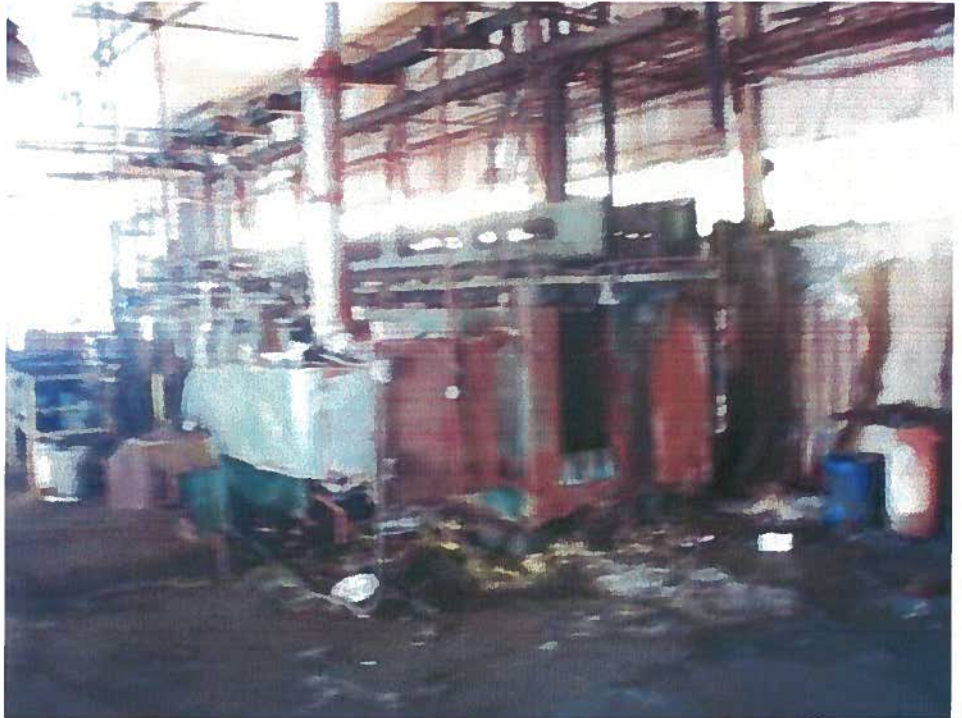
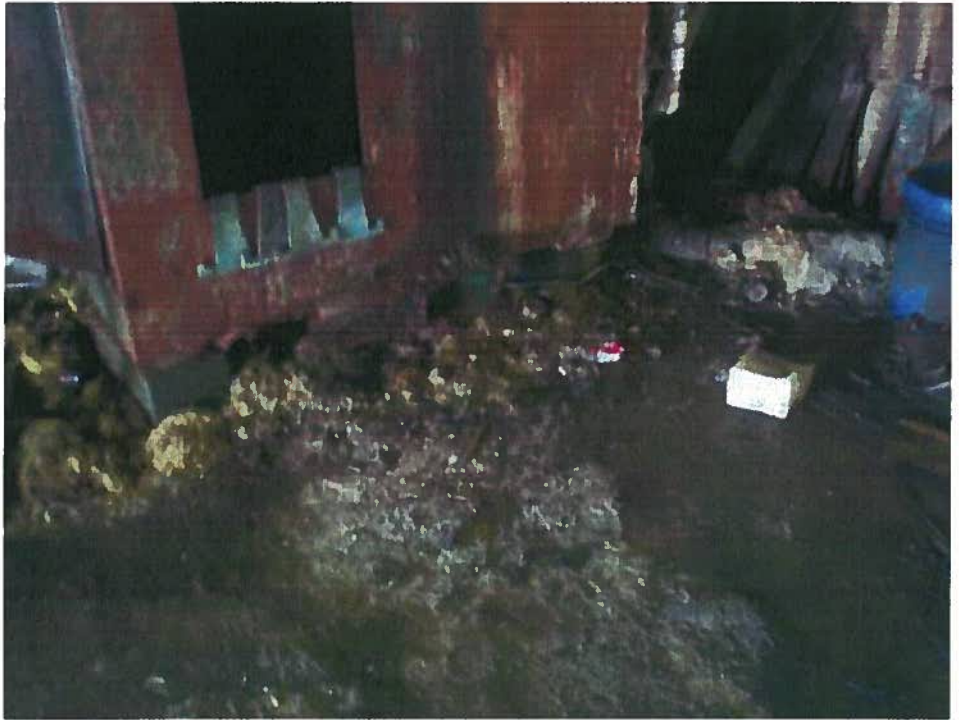
Zinc plating line. Process causes a continual spill of alkaline cleaner. Kitty litter was being placed on top of spilled material onto the floor on a continual basis. The kitty litter mix was being stored on the floor.

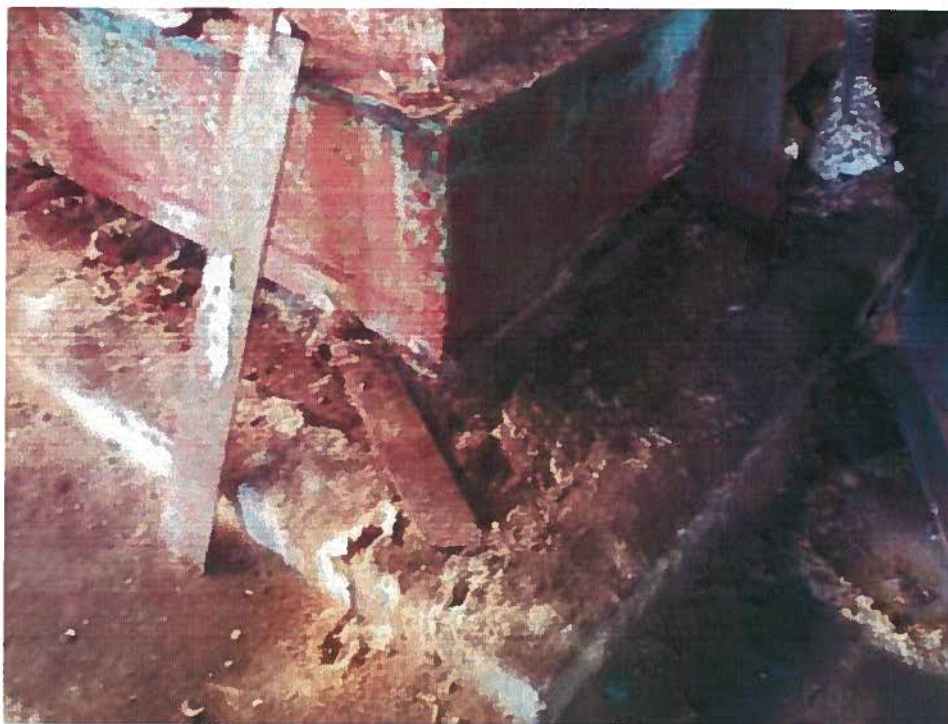
At the time of the inspection, Mid-City Plating was storing hazardous waste on-site in a containment pit located under one of the zinc plating lines, which meets the definition of a *new tank system*. A written assessment, reviewed and certified by an independent, qualified, registered professional engineer, attesting that the system has sufficient structural integrity and is acceptable for the storing and treating of hazardous waste had not been performed.

At the time of the inspection, Mid-City Plating was storing hazardous waste in a containment pit located underneath one of the zinc plating lines. Mid-City Plating had not performed tightness testing of this tank system or ancillary equipment.

At the time of the inspection, Mid-City Plating was storing hazardous waste in a containment pit located under one of the zinc plating lines, which meets the definition of a *new tank system*, without an accumulation date and without the words, "Hazardous Waste," marked on the tank.

Material was being collected and stored within the containment pit below the zinc plating line.

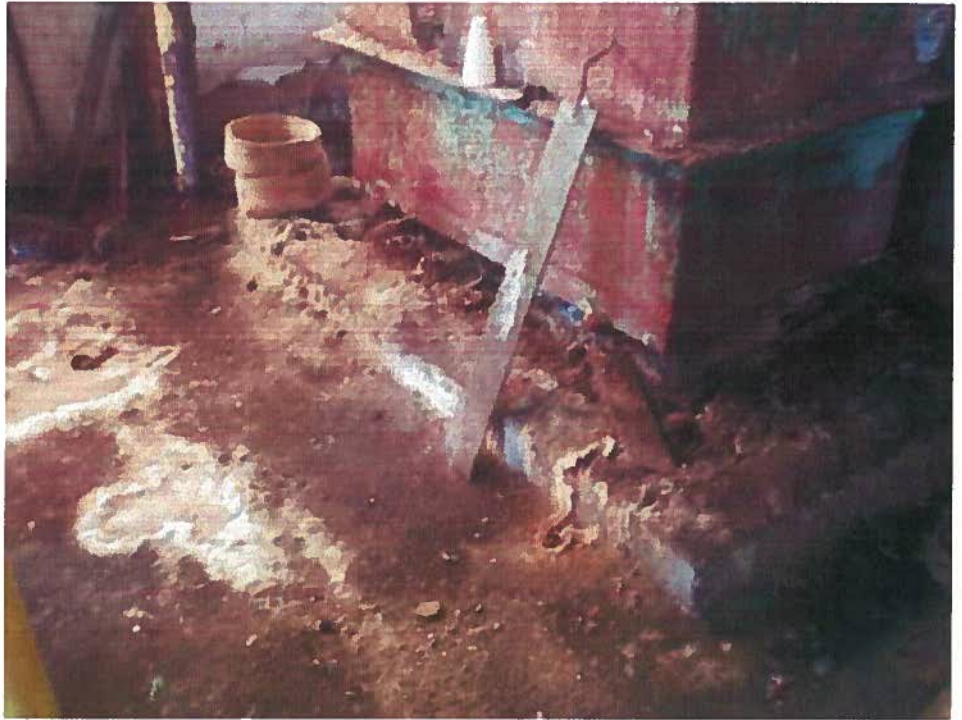
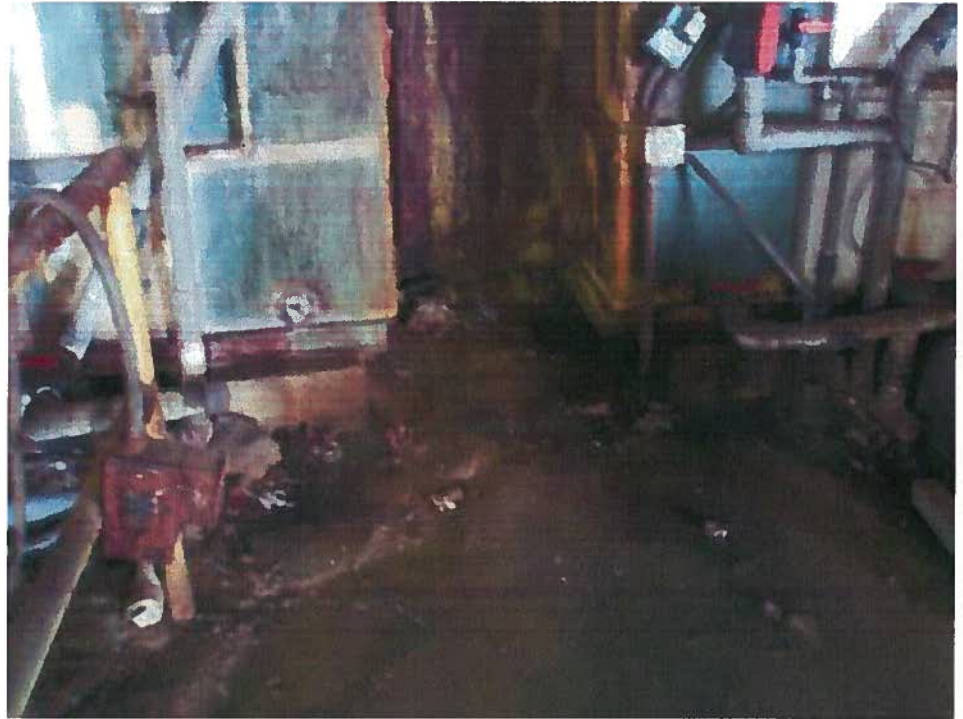
Material was being collected and stored within the containment pit below the zinc plating line. Material also was being collected and stored on the floor. Corrosion was evident on the surface of the floor.

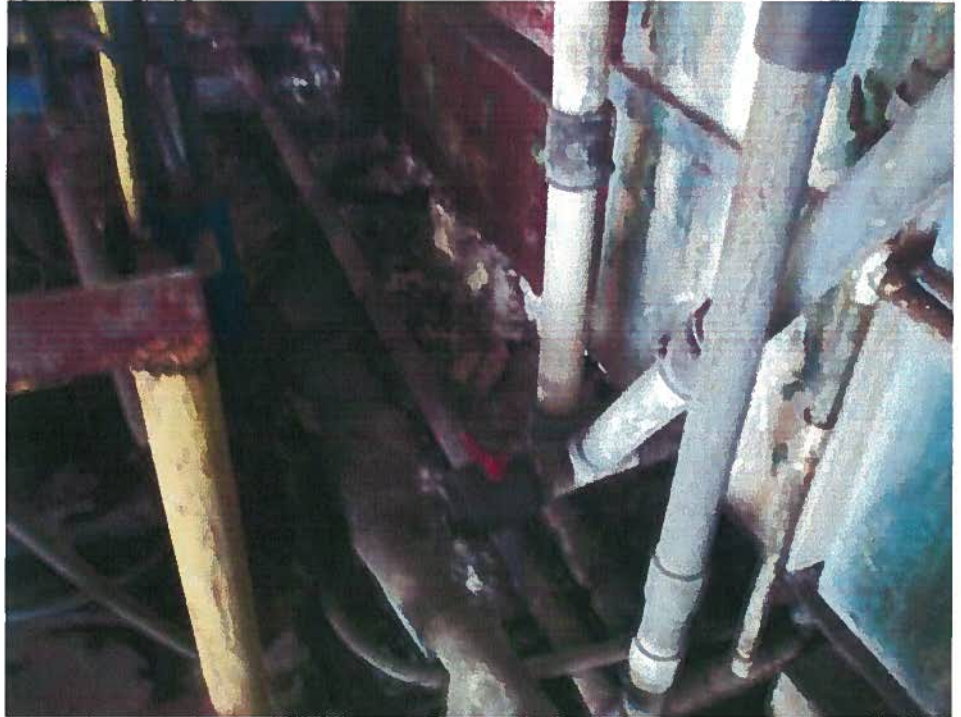
Material was being collected and stored within the containment pit below the zinc plating line. Material also was being collected and stored on the floor.

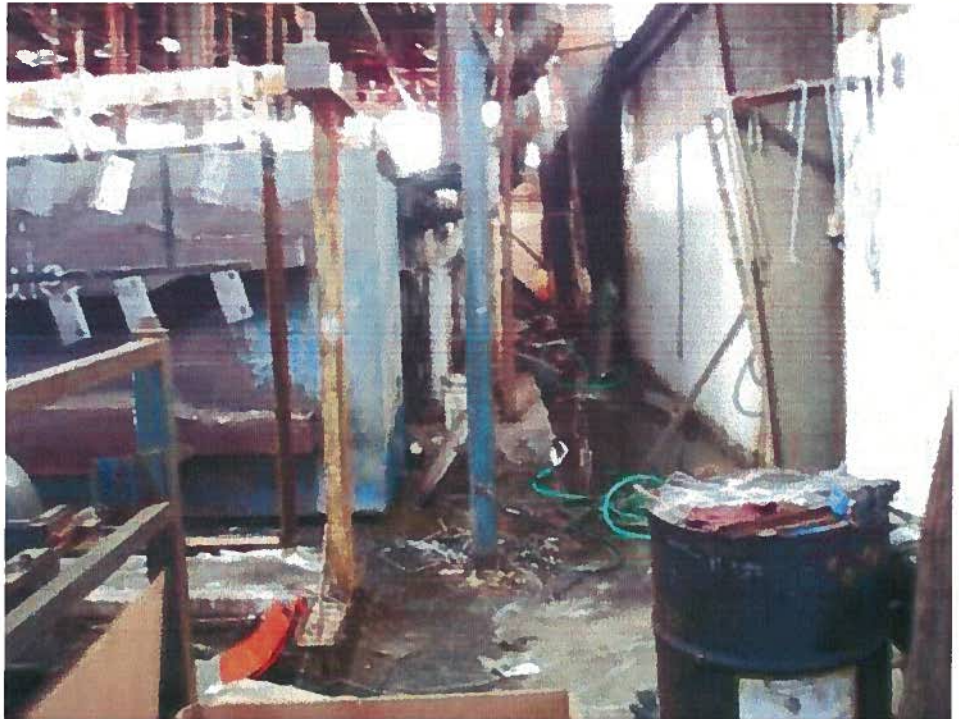
Zinc plating line. Liquid was located on floor near the line. Hoses and equipment were also located on the floor.

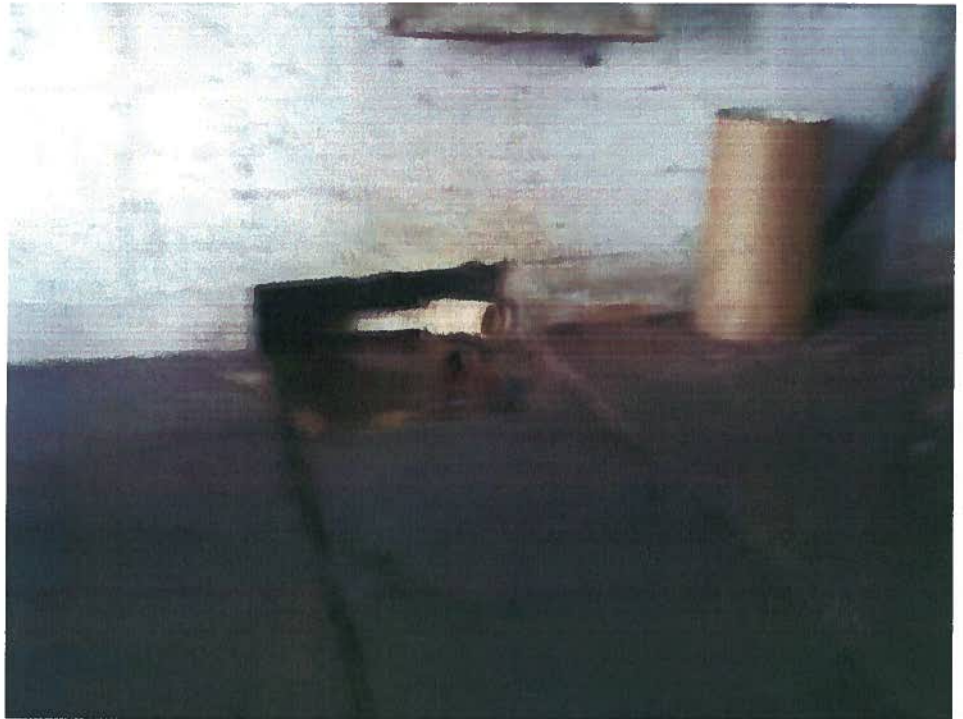
Trench located on the floor in between rooms. Red un-identified red liquid was being stored within the trench. Pipes were located inside of the trench and were not connected from the exposed ends.
